LONG-TERM PERFORMANCE AND RELIABILITY ASSESSMENT OF 8 PV ARRAYS AT SANDIA NATIONAL LABORATORIES

J. E. Granata, W. E. Boyson, J. A. Kratochvil and M. A. Quintana

Sandia National Laboratories, Albuquerque, NM

Photovoltaic Systems Evaluation Laboratory

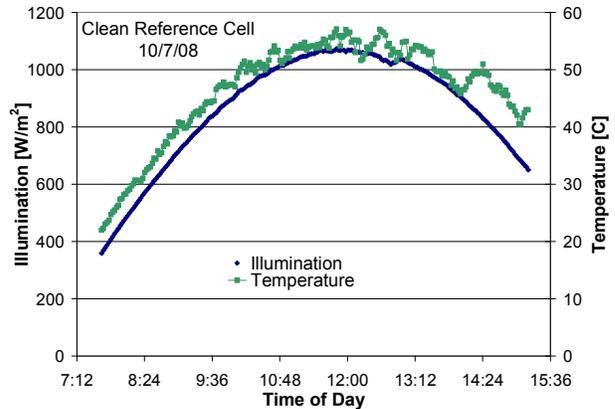
Figure 3 plots the calculated illumination based on the response from the cleaned reference cell and an average module temperature. The average weather data recorded at the neighboring PSEL was occasionally used to corroborate the analyses. Based on the accuracy of the Daystar, thermocouple data logger, and reference cell degradation of ~0.1%/year, the estimated measurement error is +/- 2.5%.

Figure 3 Illumination and module temperature during October 2008 testing
